"ENCOMBE", SANDGATE, KENT

Extracts, including principal observations and conclusions, from a Report dated 16th April, 1959 by Sir William Halcrow and Partners.

Encombe Landslip Stabilisation

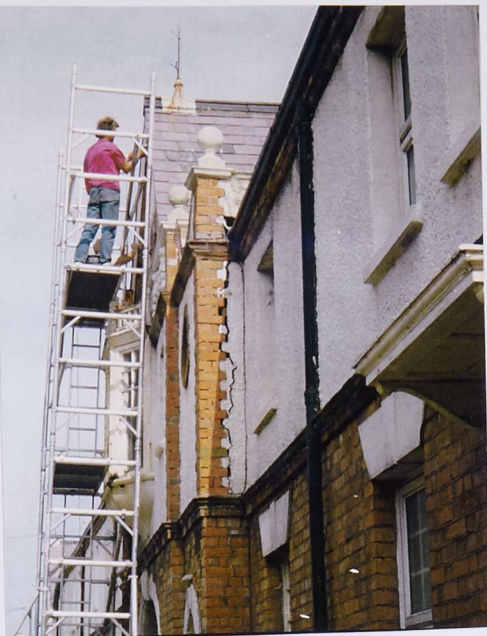
No 145, Coastguard terrace, High St. Sandgate  
Cracks before repair Oct: 1997

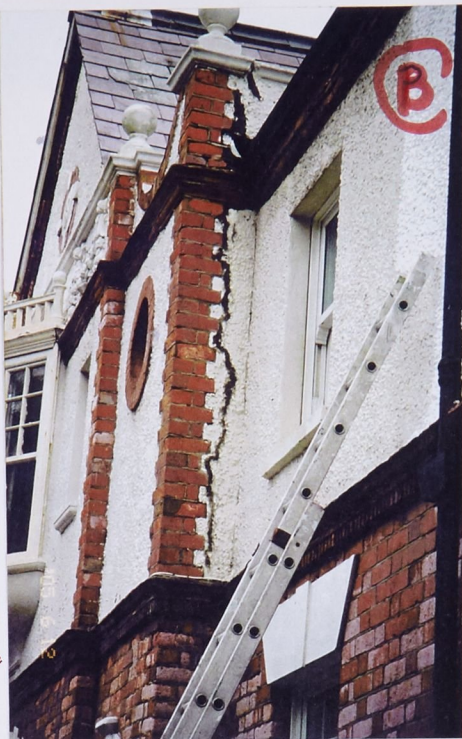
Above: Cracks re-open. 'Stopped' June 2005

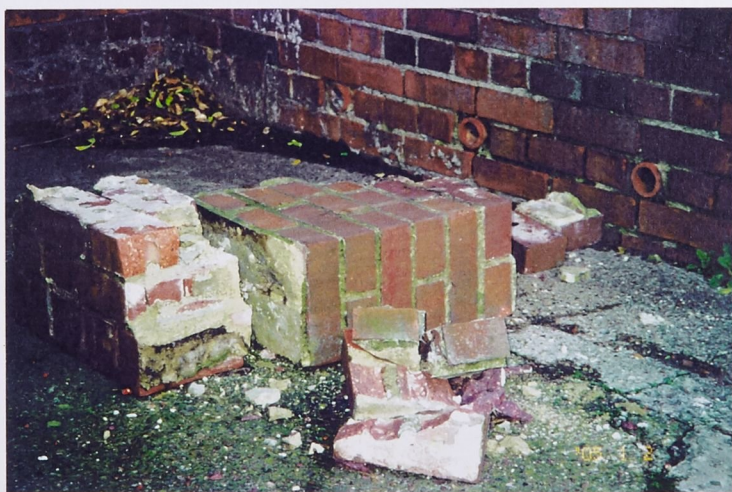
High Street Sandgate  
 Collapsed wall, 2005

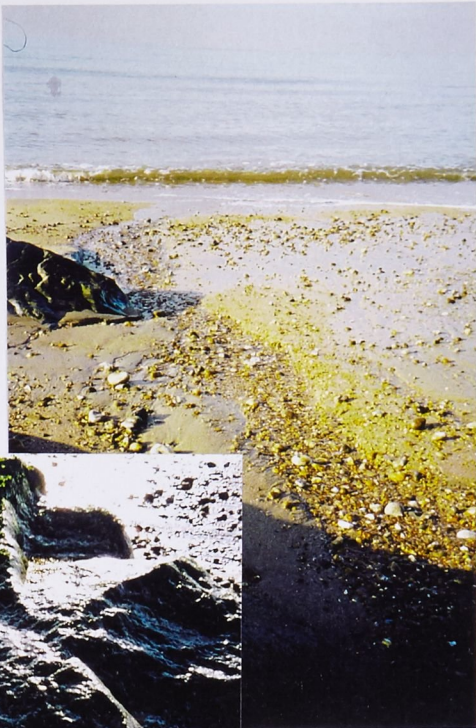
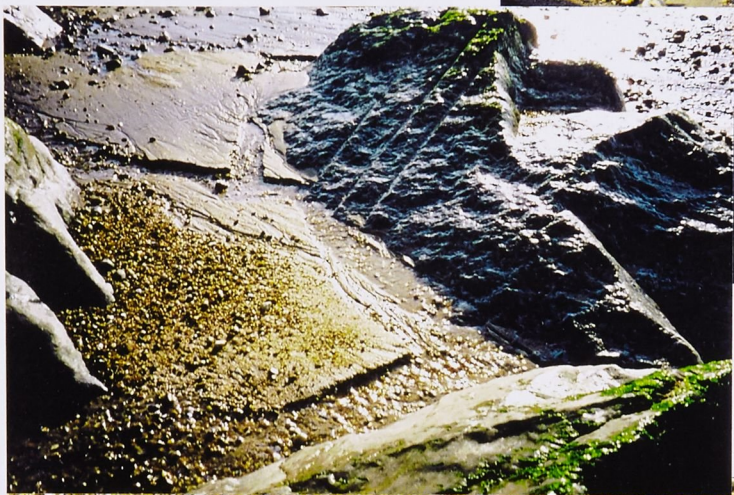
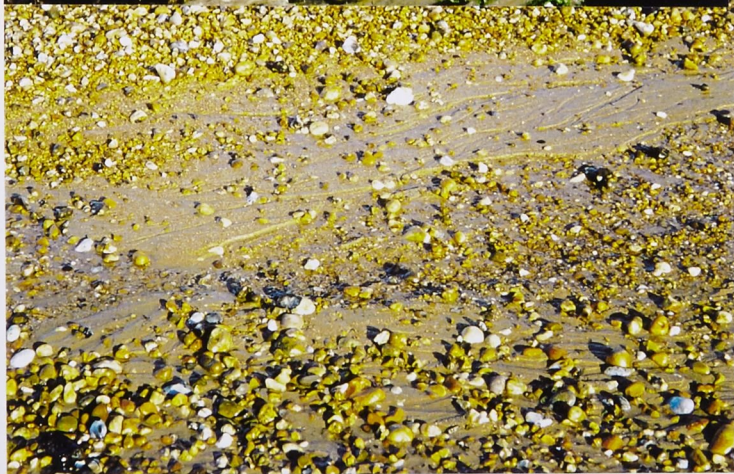
Beach fronting Encombe estate  
and C.G terrace

low tide, streams flowing  
from land to sea — also loss  
of toe weighting. Temporary  
according to littoral drift and  
spring tides.
