CONCISE HISTORY OF
EARTH MOVEMENT
SANDGATE

ENGINEERING ASPECTS OF COASTAL LANDSLIDES

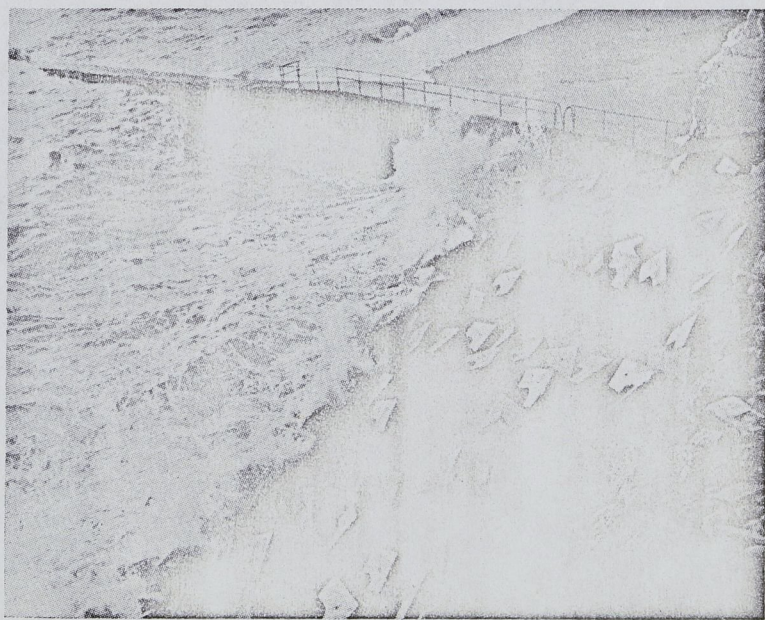
7. In stabilizing coastal slopes in soft rock, support is needed at the base, provided in such a manner as to break up waves to avoid high local pressures. Since soft rocks will continue to erode down to a wave platform, formed at approximately the level at which storm waves begin to break, any type of protection should take account of this continued drop in level of the foreshore and inshore areas. Figure 1 indicates a practicable type of protection for such a situation where a chalk cliff is exposed to attack. It is of some interest in that at this particular situation the rate of recession may be accurately estimated since the chalk cliff seen beyond the groyne in the photograph has remained stable since 1881. The annual rate of recession was locally about 25 cm per year until protection was provided first by a formal wall in 1947 and later by the illustrated revetment in 1967, when the wall was becoming undermined.

Fig. 1. View of Groyne 52 at Seaford with adjacent revetment

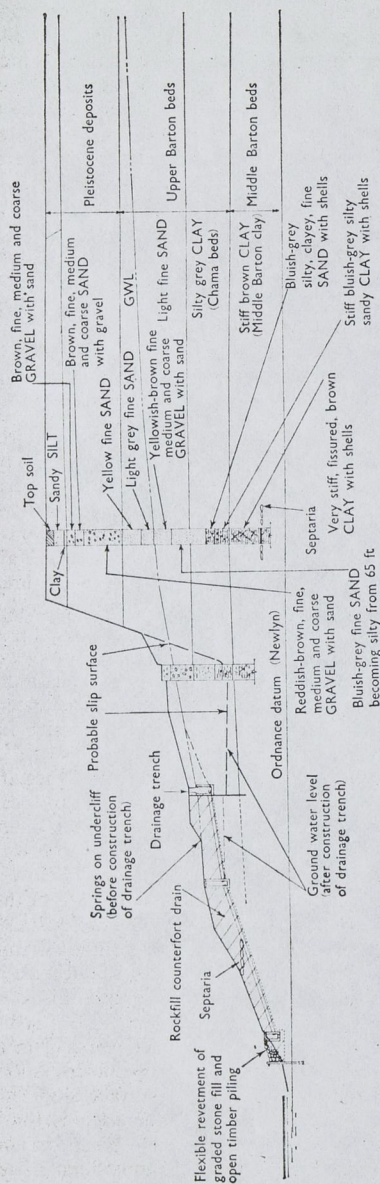
Fig. 2. Typical cross section at Barton-on-Sea undercliff indicating surfaces of sliding and remedial work

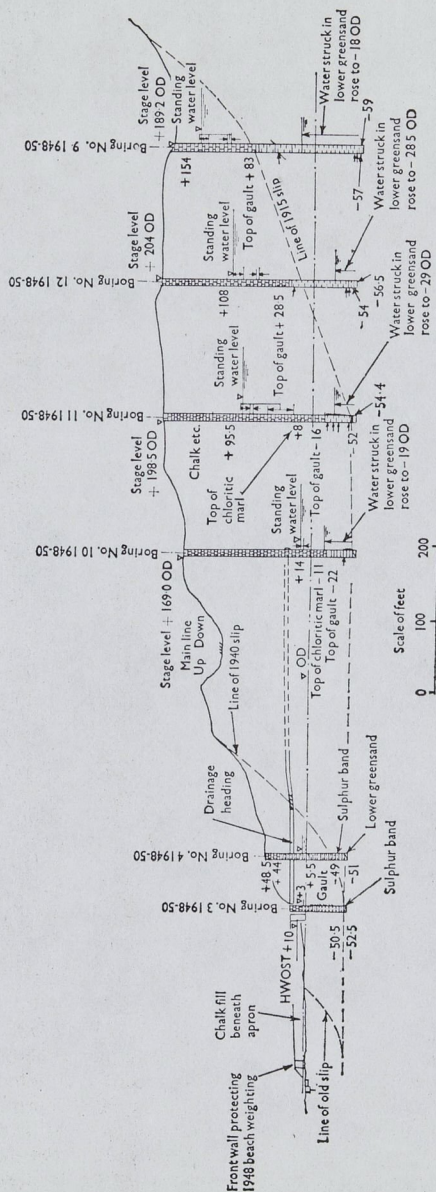
Fig. 3. Typical cross section at Folkestone Warren indicating surfaces of sliding and remedial work
