"ENCOMBE", SANDGATE, KENT

Extracts, including principal observations and conclusions, from a Report dated 16th April, 1959 by Sir William Halcrow and Partners.

Encombe Landslip Stabilisation

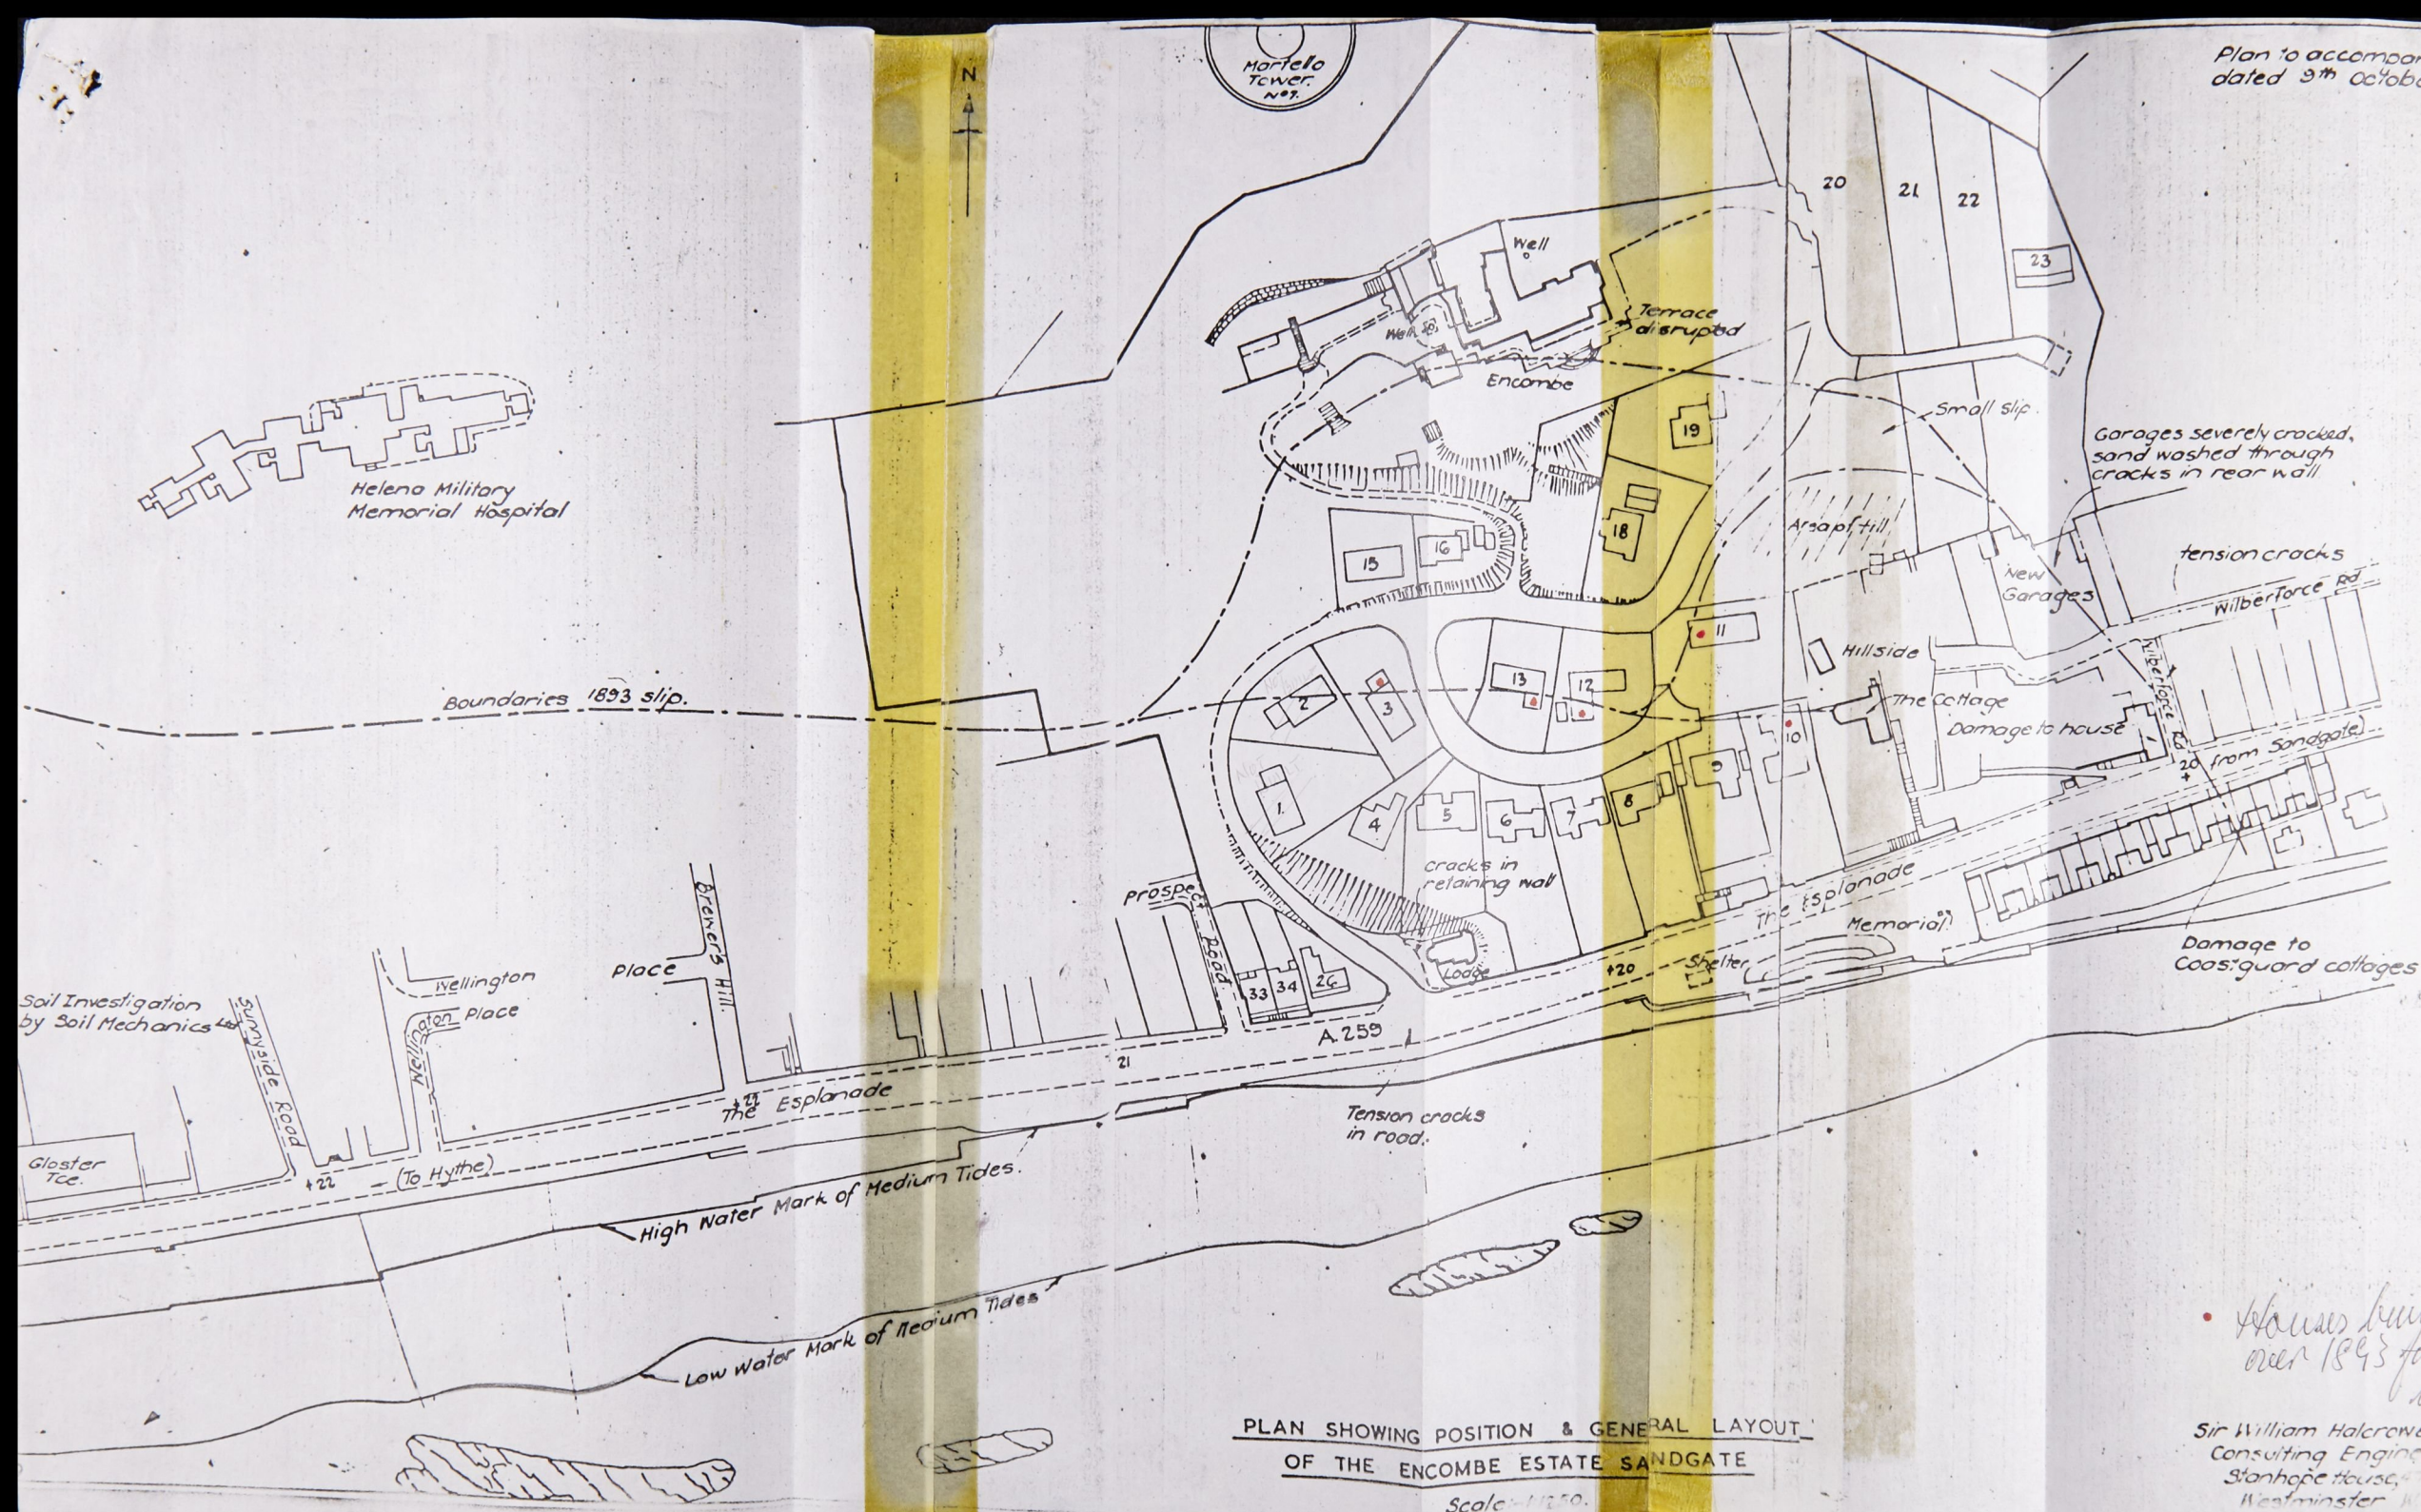
PLAN SHOWING POSITION & GENERAL LAYOUT  
OF THE ENCOMBE ESTATE SANDGATE  
Scale 1:1250.

• Houses built  
over 1893 fault  
lines p.t.  
Sir William Halcrow & Partners  
Consulting Engineers  
Stanhope House, Park Lane  
Westminster W1

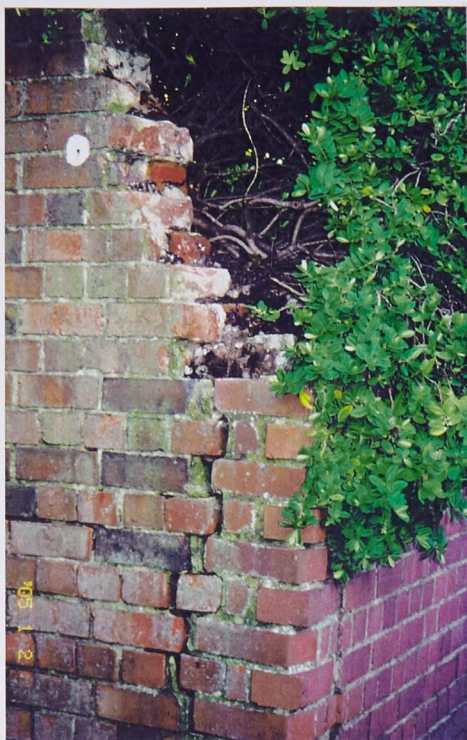
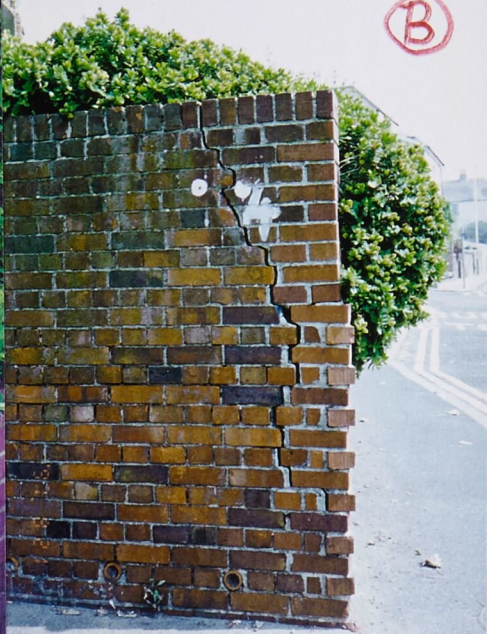
(B)

High Street Sandgate  
 Collapsed wall, 2005

Wilberforce Rd. area. Earth movement

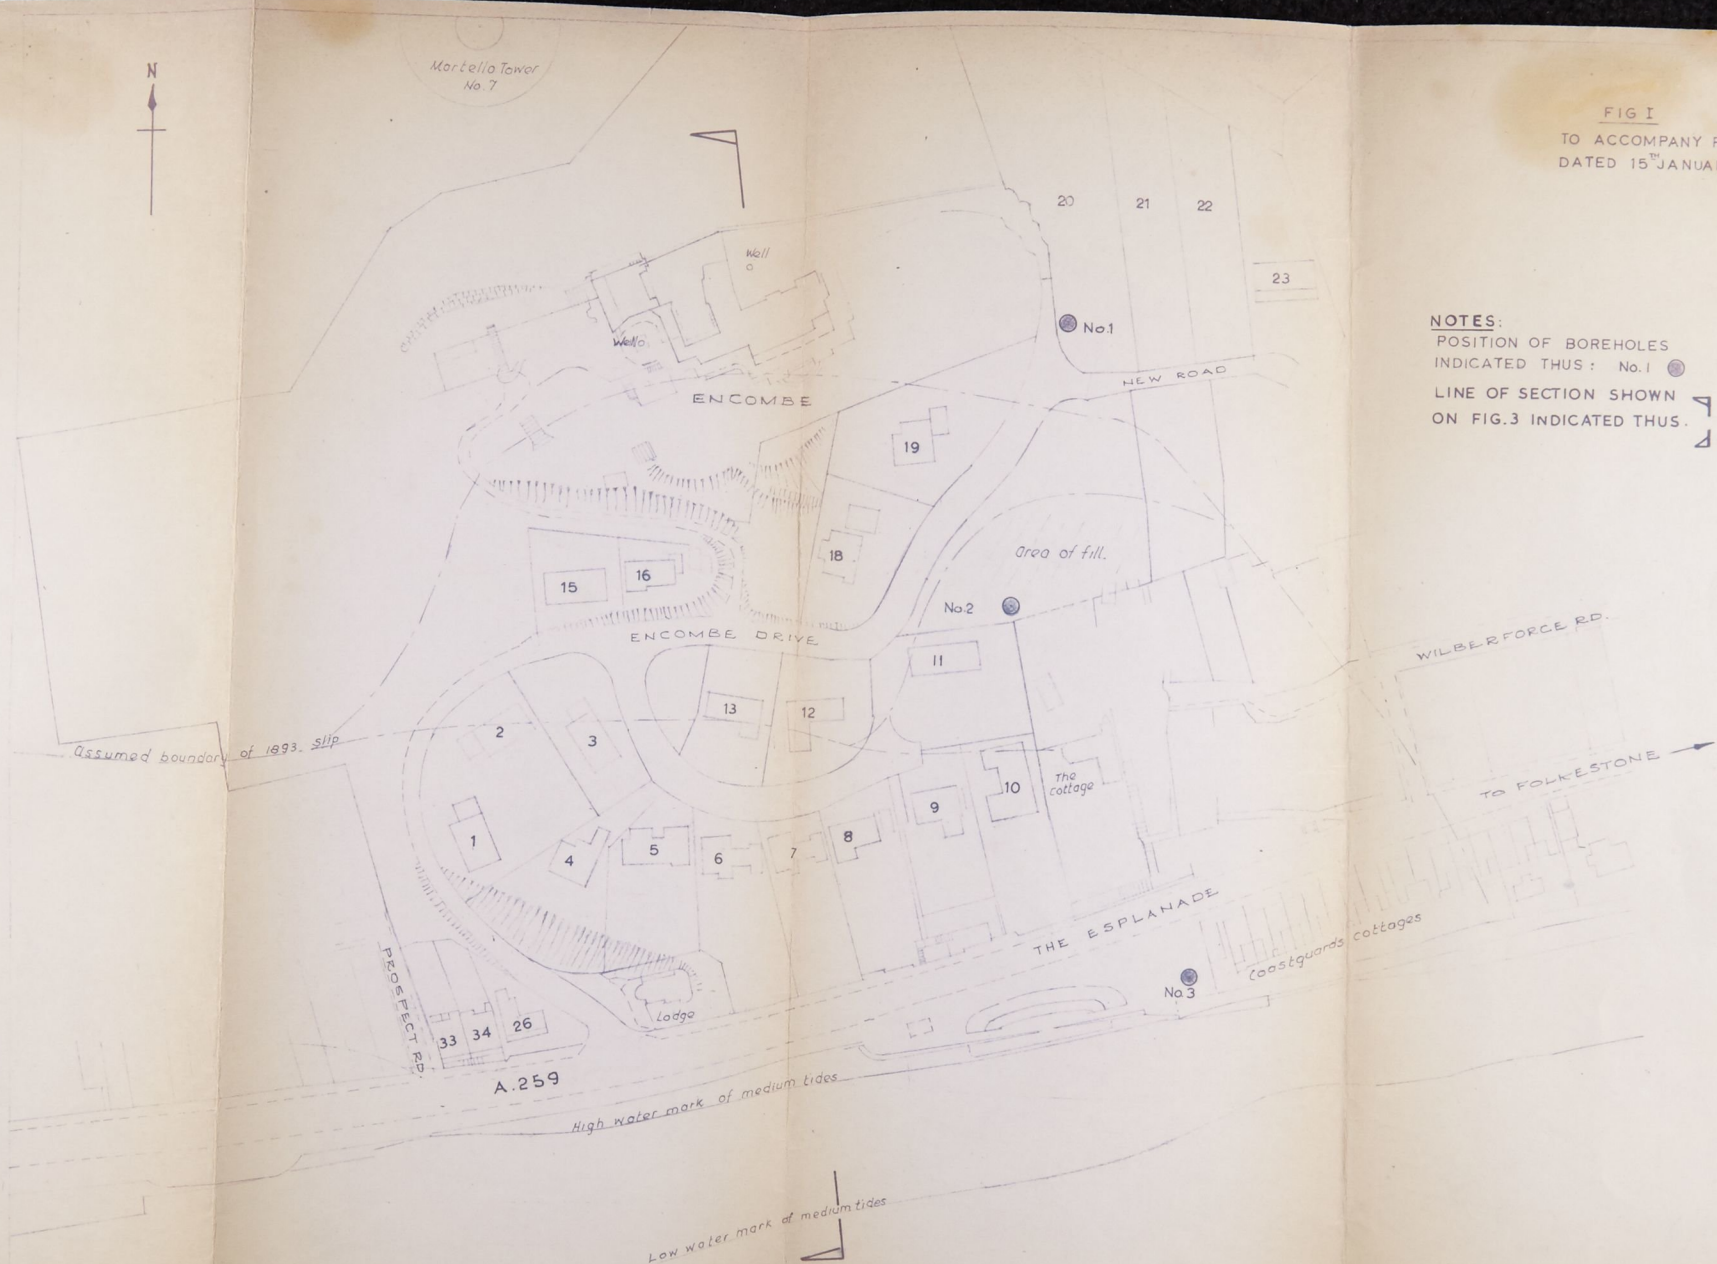
FIG I  
TO ACCOMPANY REPORT  
DATED 15<sup>TH</sup> JANUARY 1969

Fig. 1 indicates the lay-out of the area concerned and shows the position of three boreholes sunk during the recent investigation. The information provided by these boreholes is summarised on Fig. 3 on which the probable line of the boundary of slipping ground has been marked. These boreholes have also served to indicate the levels of ground water and records to date are summarised on Fig. 2.
